MISCELLANEOUS PAPER NO. 4-989

# CONDITION SURVEY, ROBERT GRAY ARMY AIRFIELD, FORT HOOD, TEXAS

P. J. Vedros

April 1968

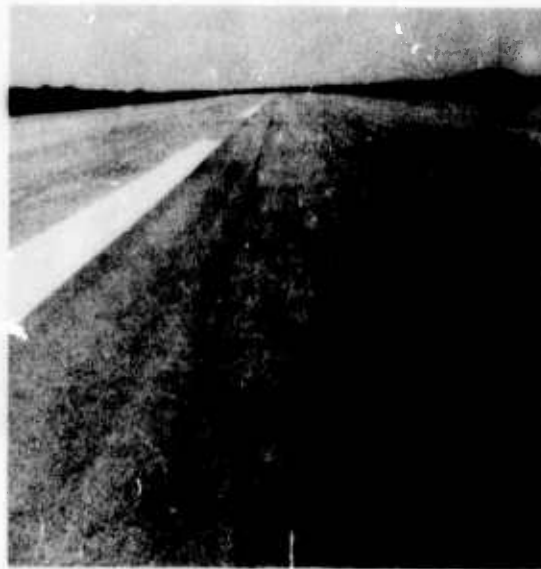
Photograph 1. Runway from sta 56+00 to 75+00, 1965 reconstruction area, is in excellent condition; June 1967

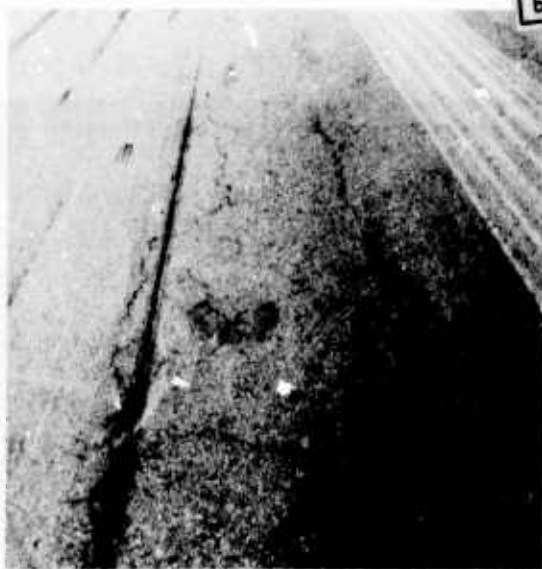
a. Random surface cracking

Photograph 2. Runway from sta 75+00 to 90+00; June 1967

- b. Maintenance in the form of crack sealing should be performed in the area from sta 75+00 to 90+00 to prevent infiltration of water into the base course. The base course contains an excessive amount of fines (approximately 15 percent passing -200 mesh) and will decrease rapidly in strength with an increase in moisture.

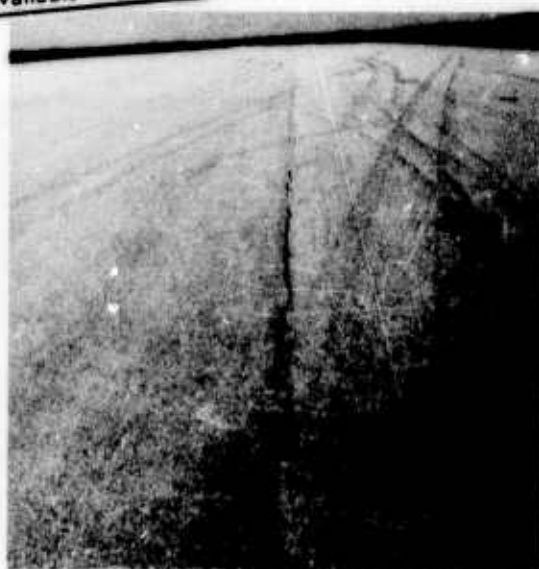
b. Opening of longitudinal joints

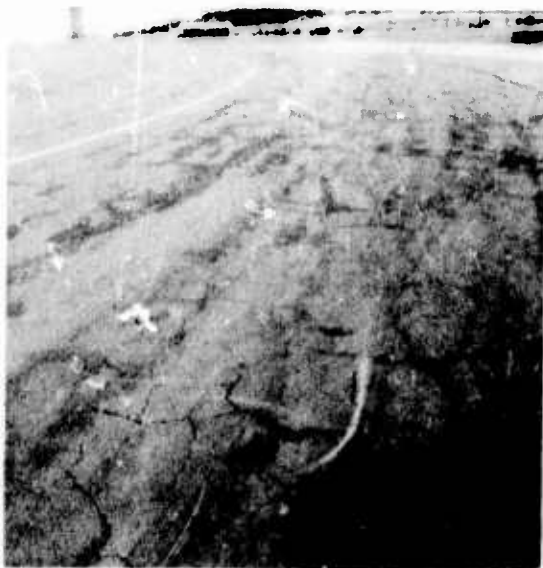
a. Taxiway leading to northwest end  
of runway

Photograph 3. Areas of pronounced surface cracking

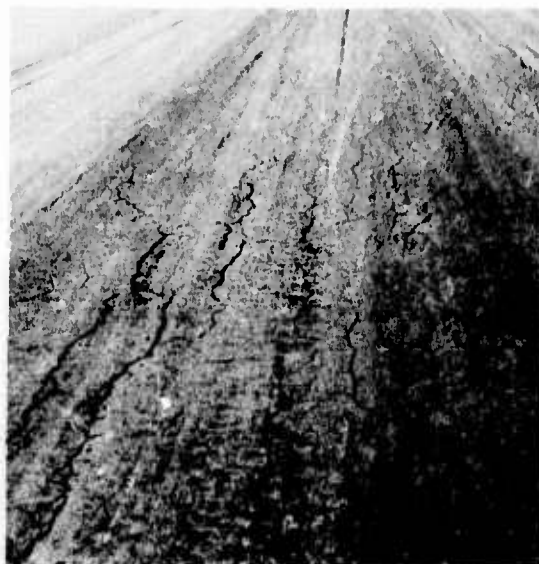
b. Northwest end of runway

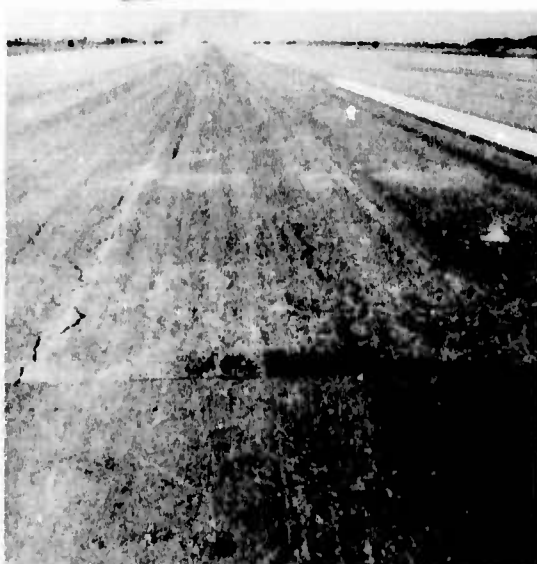
c. Sta 56+00, new construction in  
foreground

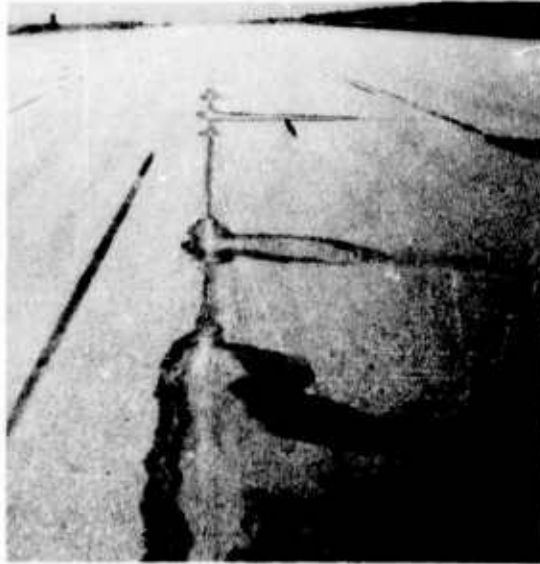
9. As described in the report of the 1964 inspection (reference paragraph 5c(2)), a seepage problem exists at this field. During certain periods, free water seeps through cracks in the pavement and puddles on the surface. Cracks have developed in the runway pavement in the area between sta 75+00 and 90+00 since the evaluation made by the WES in 1964. Seepage puddles have been observed in this area (photograph 4). There was no water standing on the pavement at the time of the current inspection, probably due to drouth conditions, but stains surrounding the cracks indicated that it had done so in the past.

Photograph 4. Evidence of water seepage in the vicinity of sta 85+00

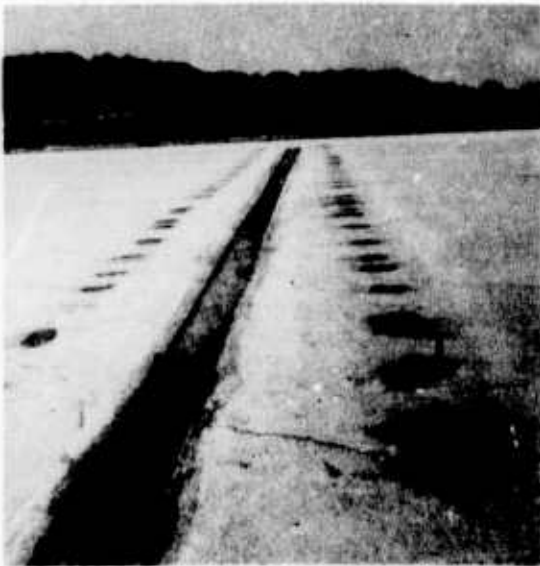
10. In an attempt to eliminate seepage in this area, the Post Engineer has installed a series of subsurface drains (photograph 5). Locations of the drains are shown in plate 3. It was reported that these drains are functioning and helping to keep the pavement relatively dry. The subsurface drains were installed at the time that the area from sta 56+00 to 75+00 was reconstructed. Layout of the drainage system is shown in plate 3.

a. Installation on east side of runway from sta 84+00 to 88+40

Photograph 5. Subdrains installed to eliminate seepage

- c. The efficiency of the subsurface drainage system should be checked periodically by WES to determine if the system is removing excess moisture from the base course material. Permeability studies by WES on similar base course material obtained from the south parking apron indicated that the material is not free-draining, and drains would be ineffective in reducing the saturated condition of the base course.

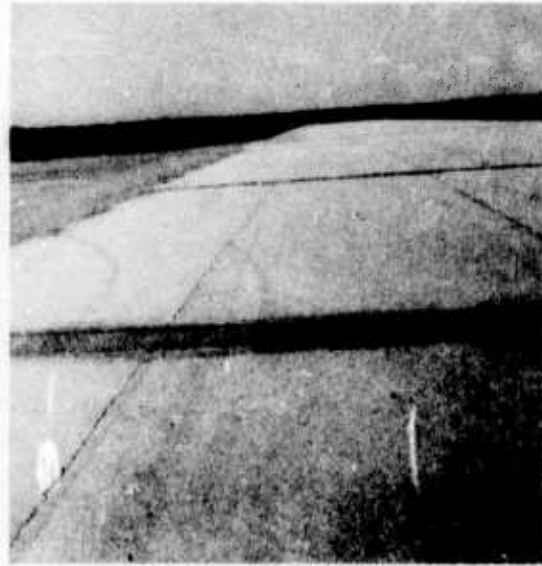
b. Installation on west side of runway from sta 88+40 to 90+00
